Development of a dynamic testing procedure to assess crashworthiness of the rear patient compartment of ambulance vehicles

Paper # 454

Nadine Levick, Guohua Li

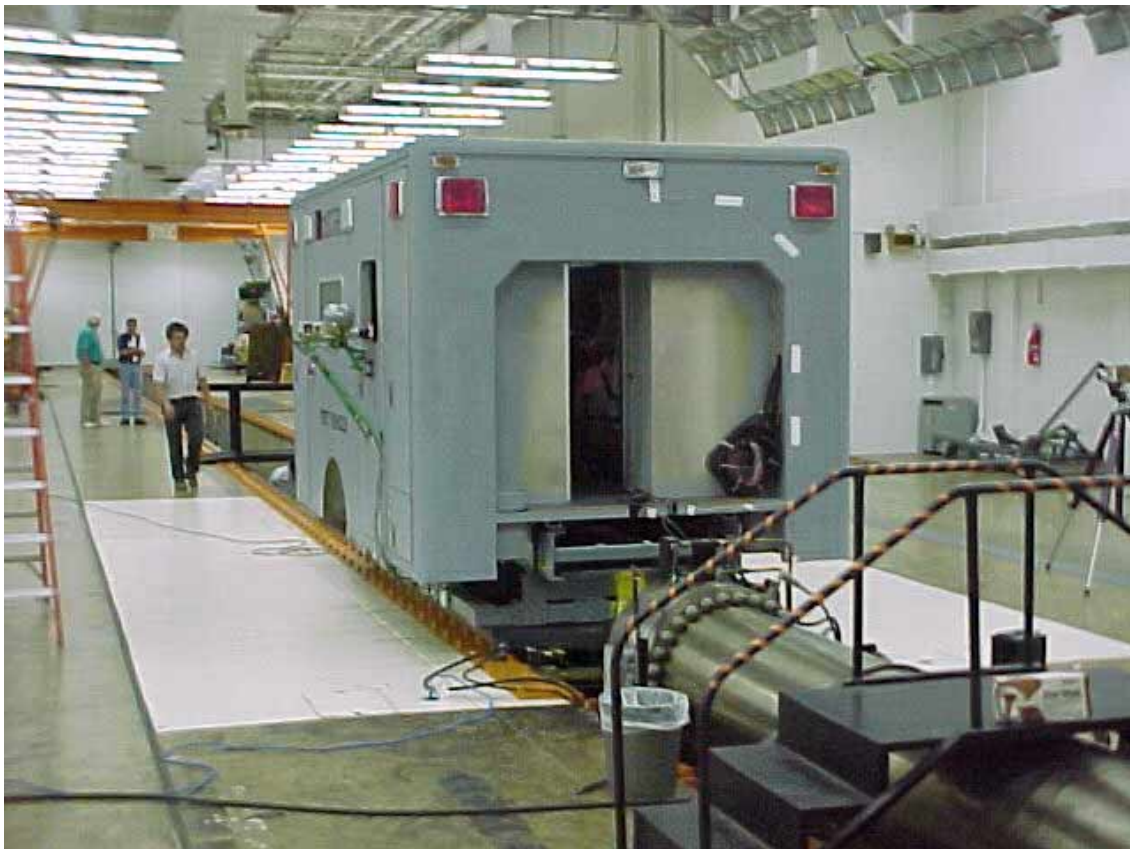
Figure 1. Ambulance rear patient compartment on HYGE accelerator rig

One frontal impact test of the rear patient compartment of a 1999 ambulance box (figure 1) manufactured by a major ambulance manufacturer was conducted. The primary purpose of the sled test was an industry initiative to analyze the mounting mechanism of the rear patient compartment to the chassis and also to assess a new gurney and gurney mounting system. The research teams involvement in this test was a secondary purpose and a largely fortuitous opportunity. Overall this test was performed to evaluate the performance of :

This test was conducted on a HYGEE test sled which generated the required acceleration pulse. There was no crash test data available to determine the exact pulse experienced in a crash of an ambulance. Without any information to make an informed decision to change the pulse, the same pulse that was used in a similar test in 1991 for the test was used in this study. Both the 1999 and 1991 tests the target sled pulse was 26 G and 30 mph.

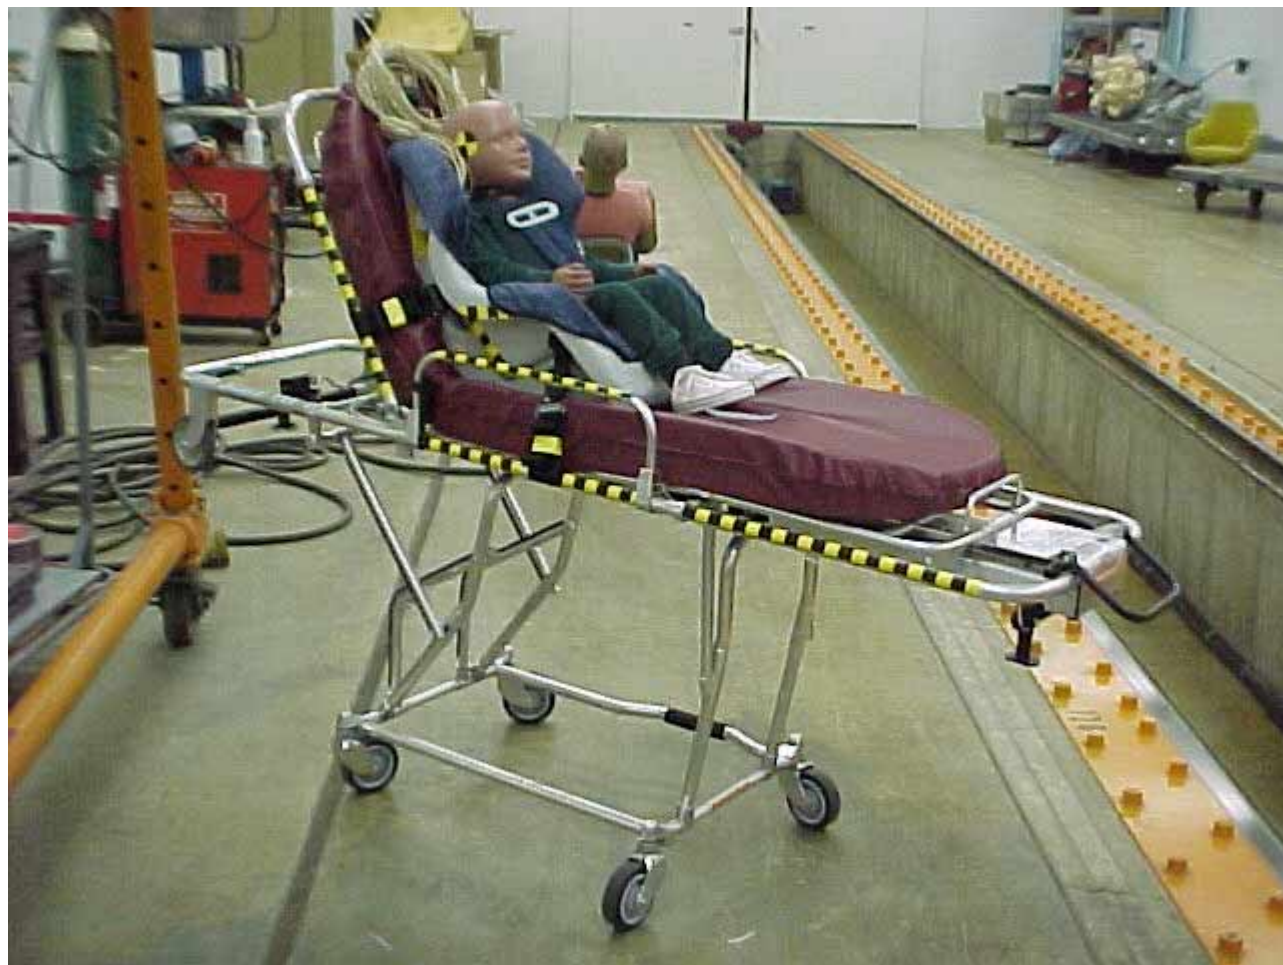
Figure 2. CRS and Child ATD Installed on stretcher

- The three year-old Hybrid-III (H-III) child ATD was positioned in a standard passenger vehicle convertible child restraint seat (CRS) with a standard five-point harness. This safety seat was attached to the stretcher with 2 standard patient restraint belts. (Figure 2)
- The 50th percentile male Side Impact Dummy (SID) was unrestrained and seated at the forward end of the squad bench equipped with the passive restraint device. (Figure 3)
- A 95th percentile male Hybrid-II ATD (un-instrumented) was restrained in the rear most position of the squad bench, a side facing position and was restrained with the lap belt normally fitted to the vehicle (Figure 3)
- A 95th percentile male Hybrid-II (un-instrumented) was positioned in the rear-facing attendant's seat (Captains Chair) and was restrained with the lap belt normally fitted to the vehicle.

The child restraint system appeared to perform well in this test. It remained well secured to the stretcher throughout the impact. Post-test inspection of the CRS revealed that the shell had marks consistent with belt loading on the upper child harness slots and the rear-facing belt path slots. There was minor bunching of the child restraint harness at the latch plates. Neither of the belts used to restrain the CRS to the cot showed any significant signs of loading. All of these facts are consistent with the expected loading in this test. There were no signs that the CRS was nearing the limits of its ability to protect an occupant, nor was there any evidence of substantial occupant motion during the test.

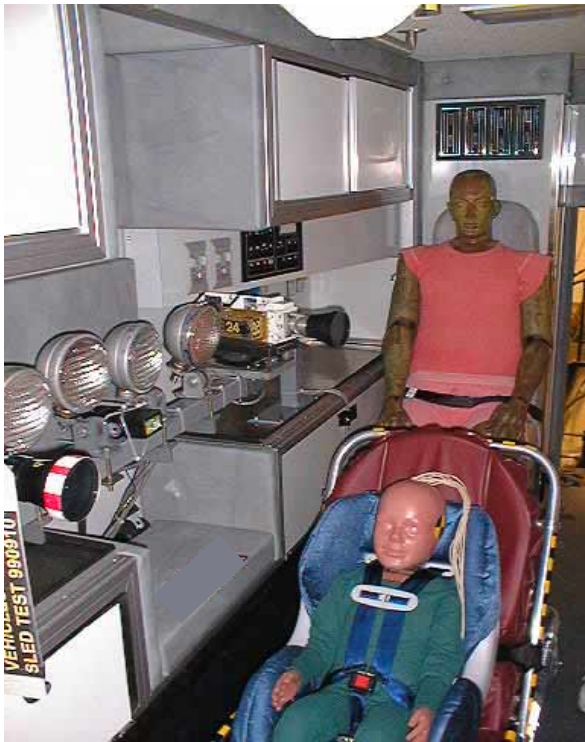
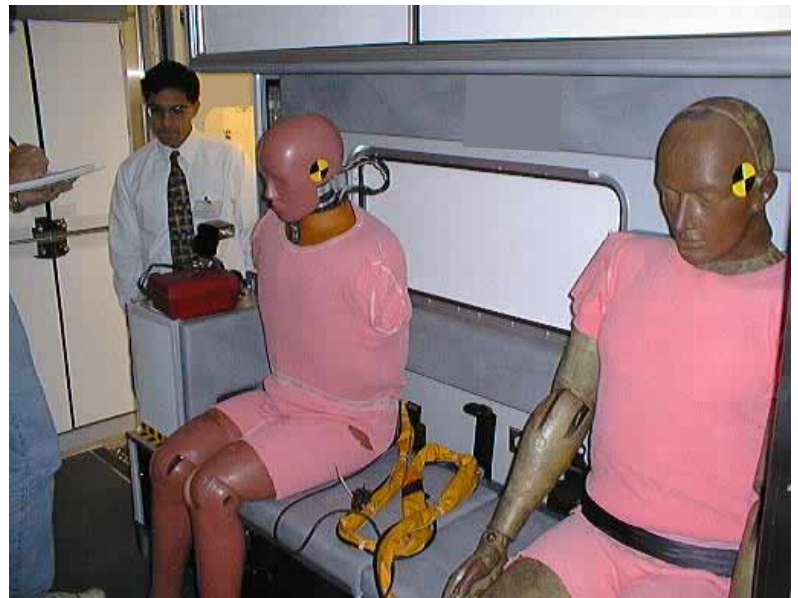
Figure 3a and b. Interior of the ambulance box and the ATDs on the Squad Bench, Captains Chair and gurney

Inside the box were four ATDs. Their seating positions and method of restraint was as follows:

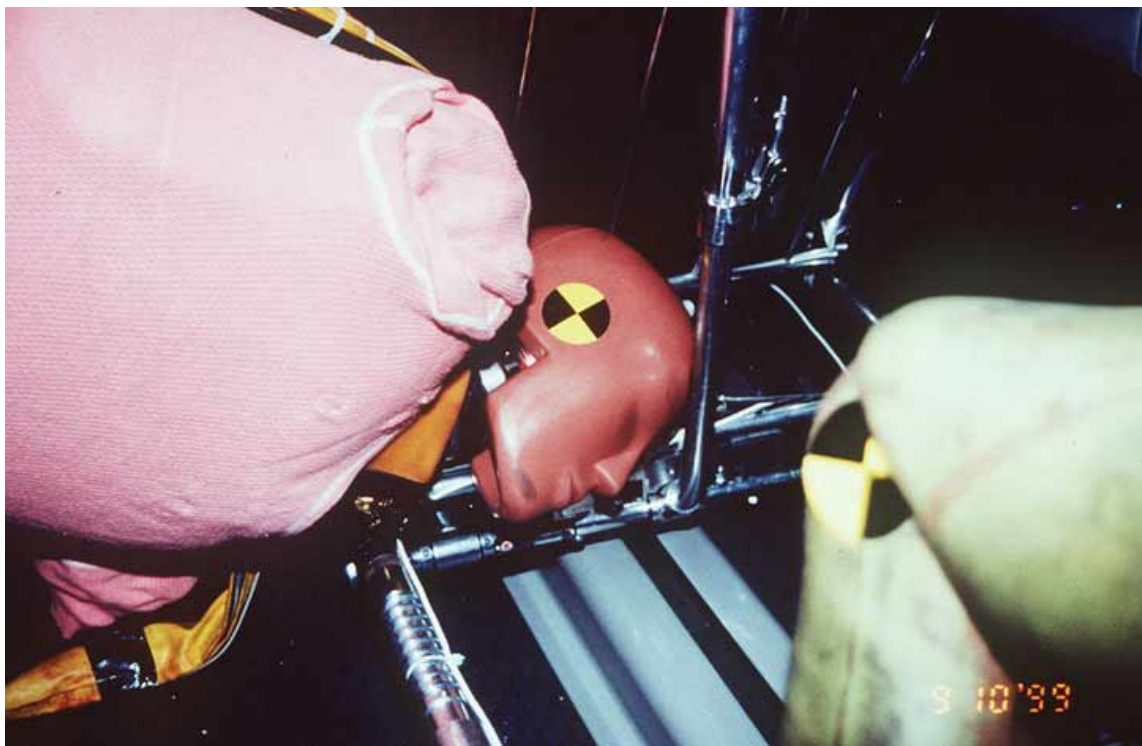
Fig. 4 Post crash test configuration of unrestrained SID

After impact, the ATDs that were restrained remained in approximately their pre-test positions. The unrestrained SID impacted and fragmented the passive restraint device. This device failed to restrain the SID, which then became airborne and impacted the forward bulkhead cabinet with its head. The HIC was projected to be greater than 1000, due to the high velocity impact of head into a rigid surface. The SID's final rest position was lying forward of its initial position, near the top of the stretcher, with the head within the structure of the stretcher (figure 4). The H-III child ATD was in approximately the same position pre and post-test and demonstrated minimal motion during crash event. The HIC recorded from the restrained child ATD was 171. The side facing ATD remained restrained, however kinematic analysis demonstrated that the upper body rotated laterally 90 degrees to the horizontal position with some excursion of the pelvis. The rear facing ATD demonstrated minimal motion, and appeared fully supported by the seat back throughout the crash event. This occupant appears to be in approximately the same position pre and post-test, though the ATD is shifted slightly forward

With regard to the SID, there was data loss due to disruption of data channels upon impact, however the high head acceleration values measured are of great concern. The SID crashed through the passive restraint on the forward end of the crew bench and impacted the front bulkhead cabinet. The head accelerations for the SID prior to head impact were very low indicative of a lack of coupling between the dummy and the vehicle, as expected with no seat belt used. The electronic data in conjunction with the SID's kinematics suggest that this occupant would likely have sustained a high severity injury to both the head and the lower spine and a major soft tissue injury to the liver and other abdominal structures.
